# Ground Water Depletion from Residential Development in A Tertiary Aquifer, Emerald Ridge Subdivision, Southern Lewis & Clark County

Lewis & Clark Water Quality Protection District  
James Swierc, P.G.  
October 2014

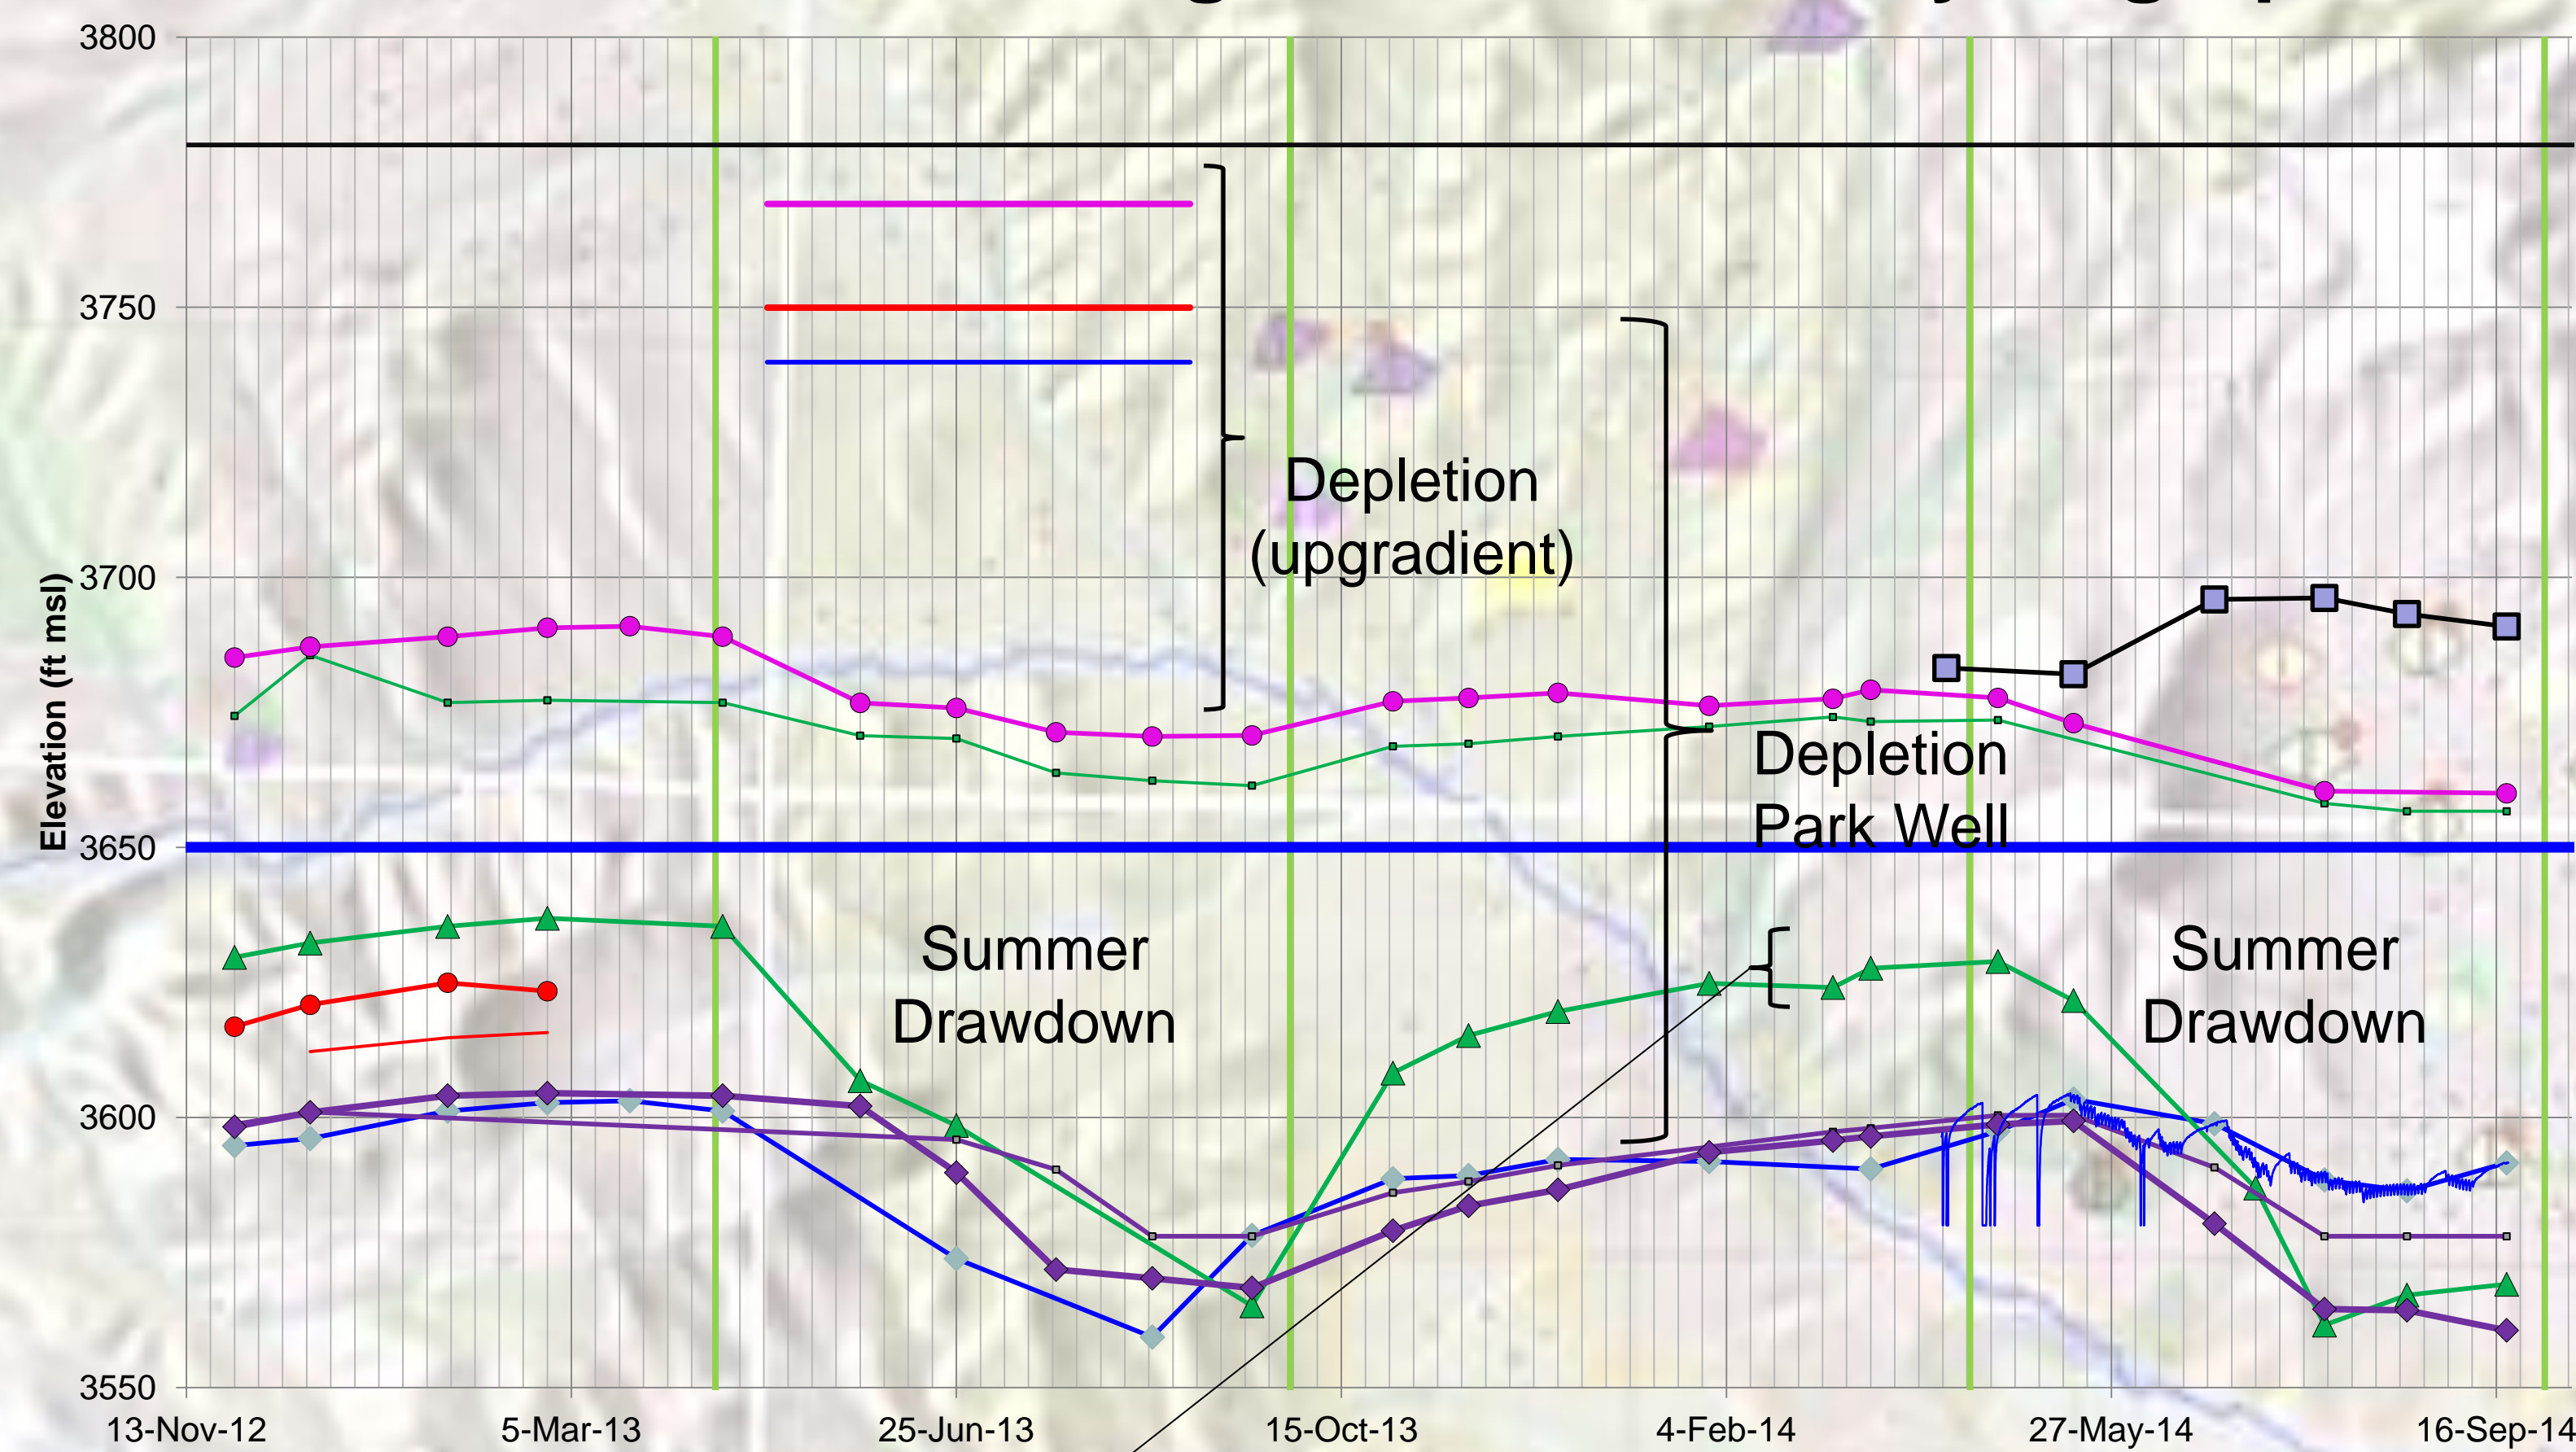
## Emerald Ridge - Water Level Hydrograph

Doesn't Recharge to Previous year level

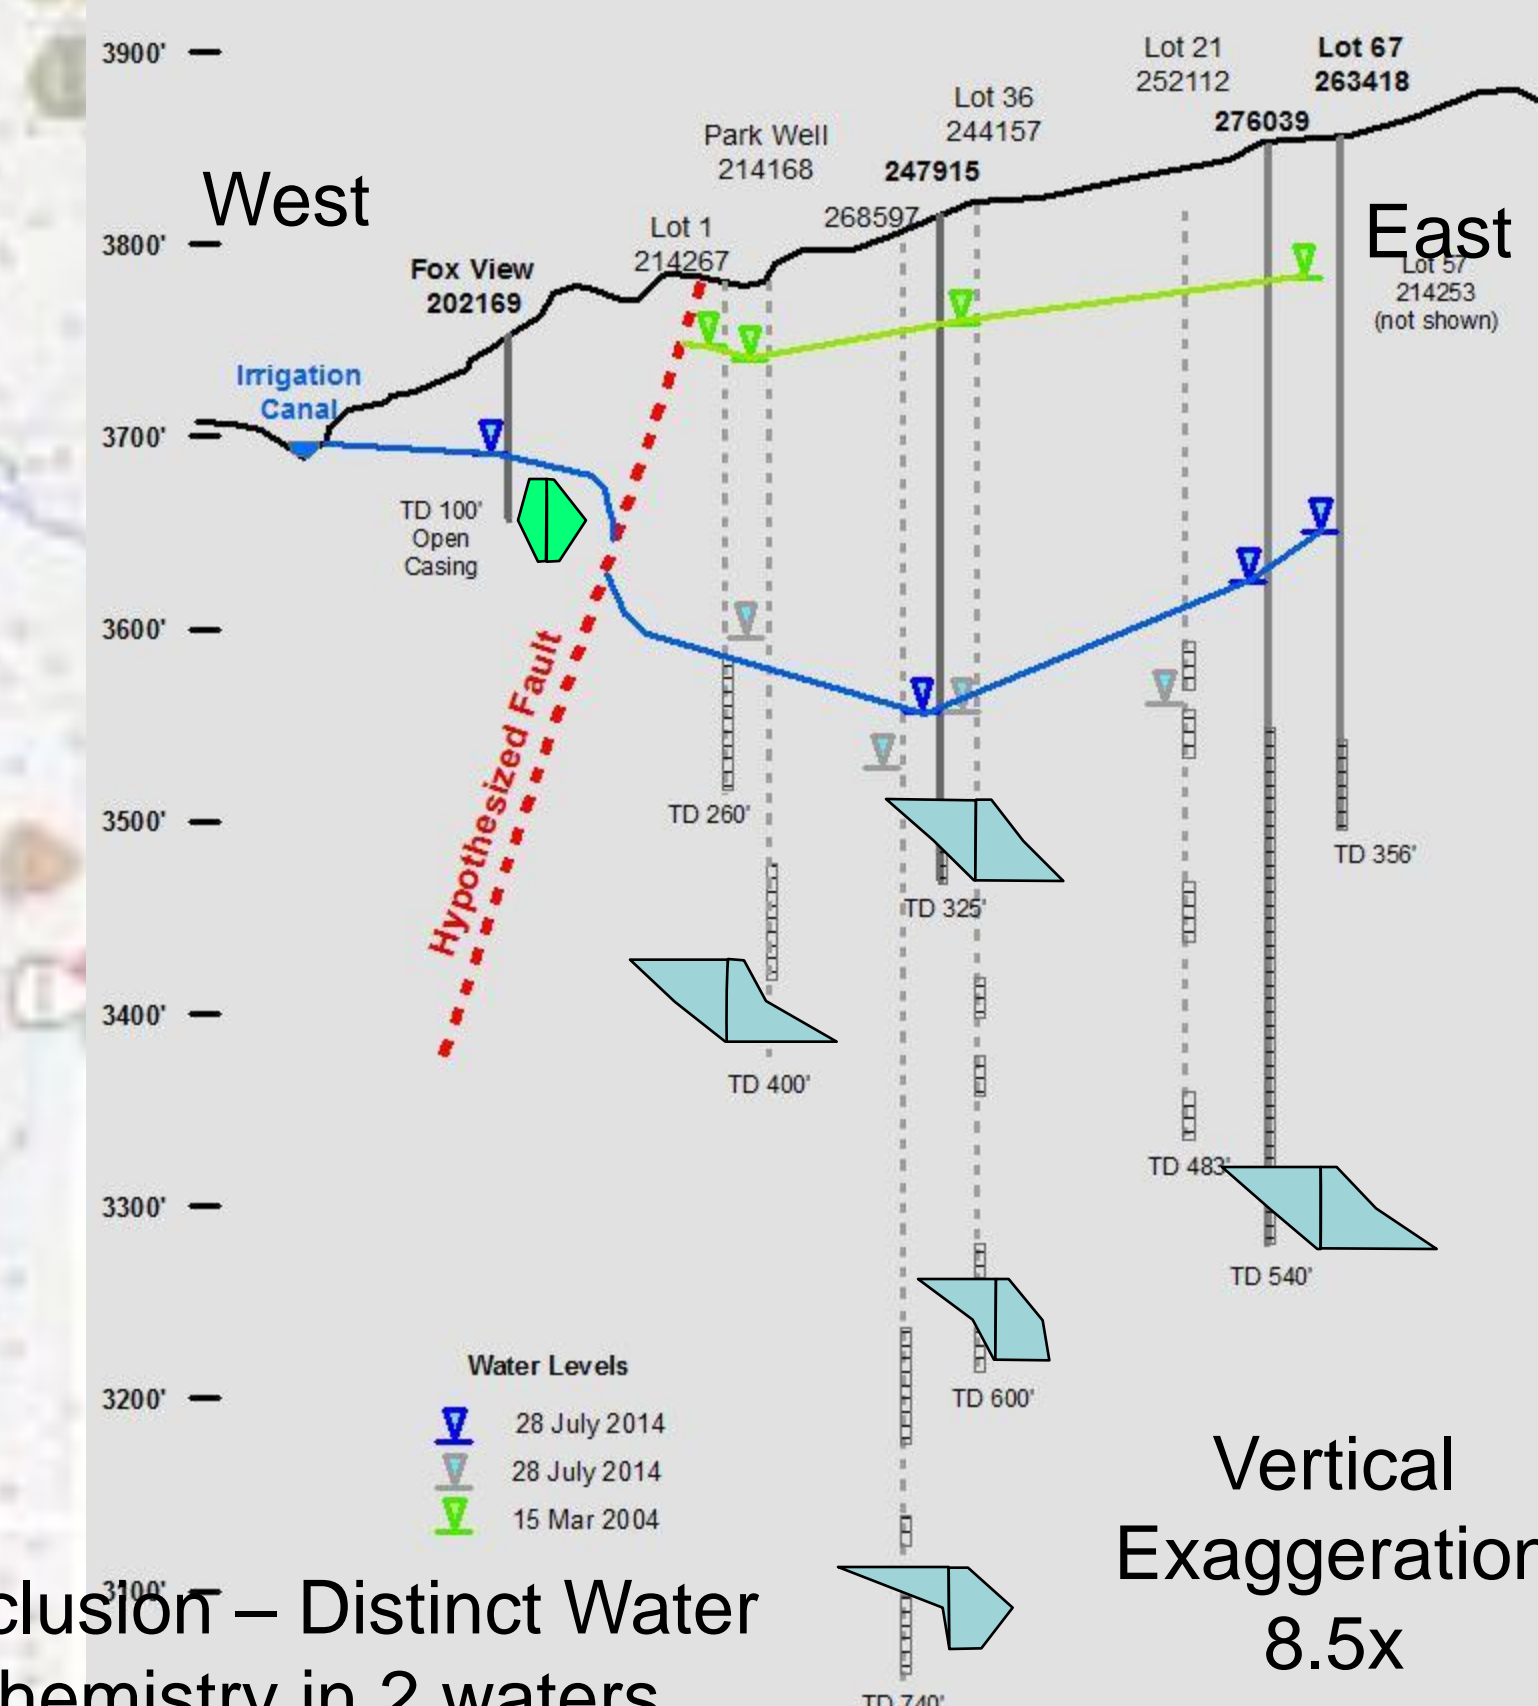
Ground Water Depletion  
- Pumping Exceeds Recharge  
- Water Levels Decline

Conclusion – Distinct Water Chemistry in 2 waters  
Stiff Diagram Explanation

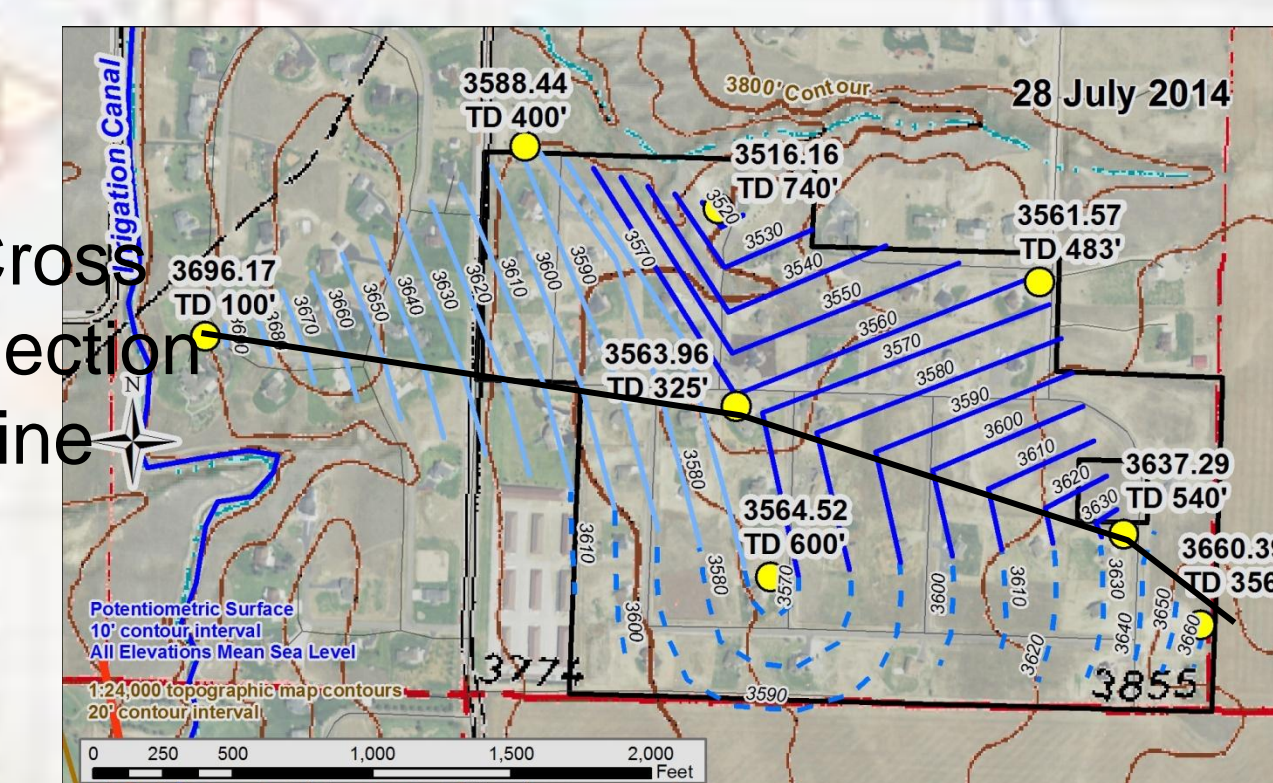
## Water Table Surface (28 July 2014)

Conclusion – Ground Water Flow Direction has Changed

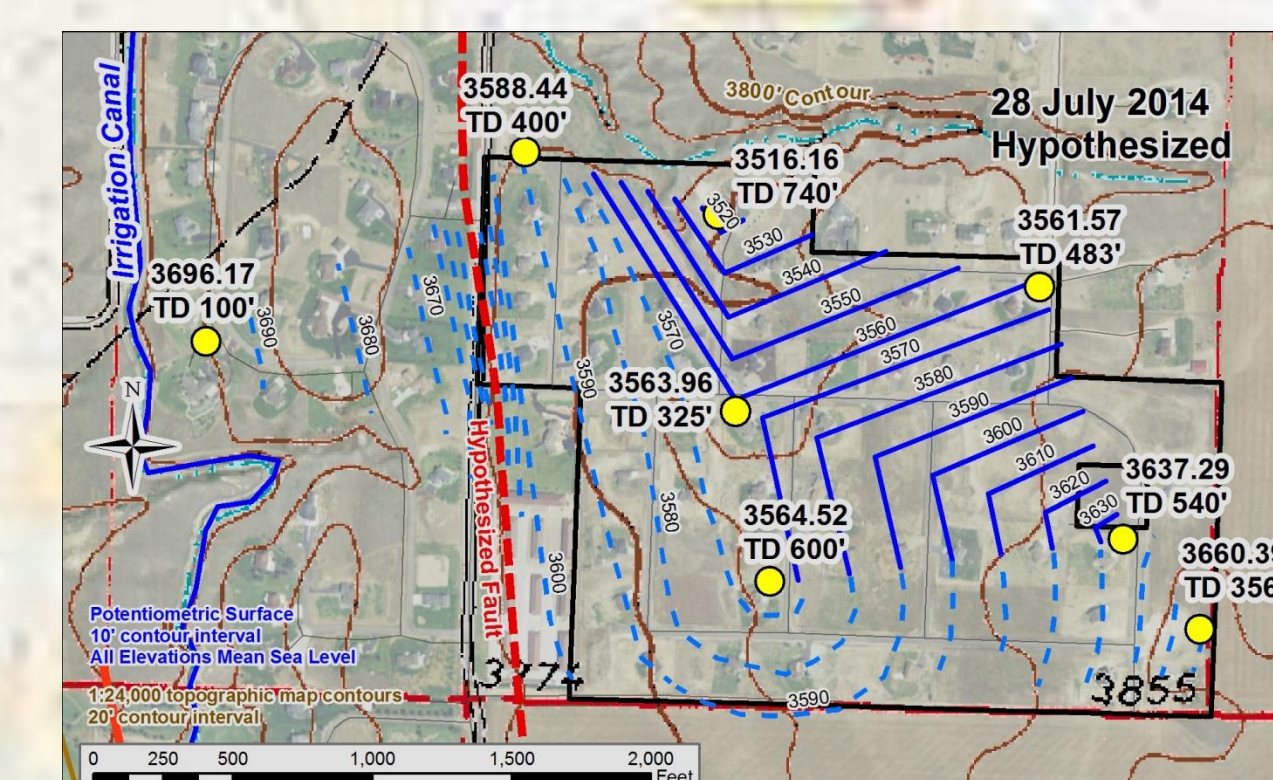
28 July 2014;  
with Hypothetical Fault seal

Ground Water recharge from Helena Valley Not Occurring – Fault Hypothesized as seal to water flow/recharge

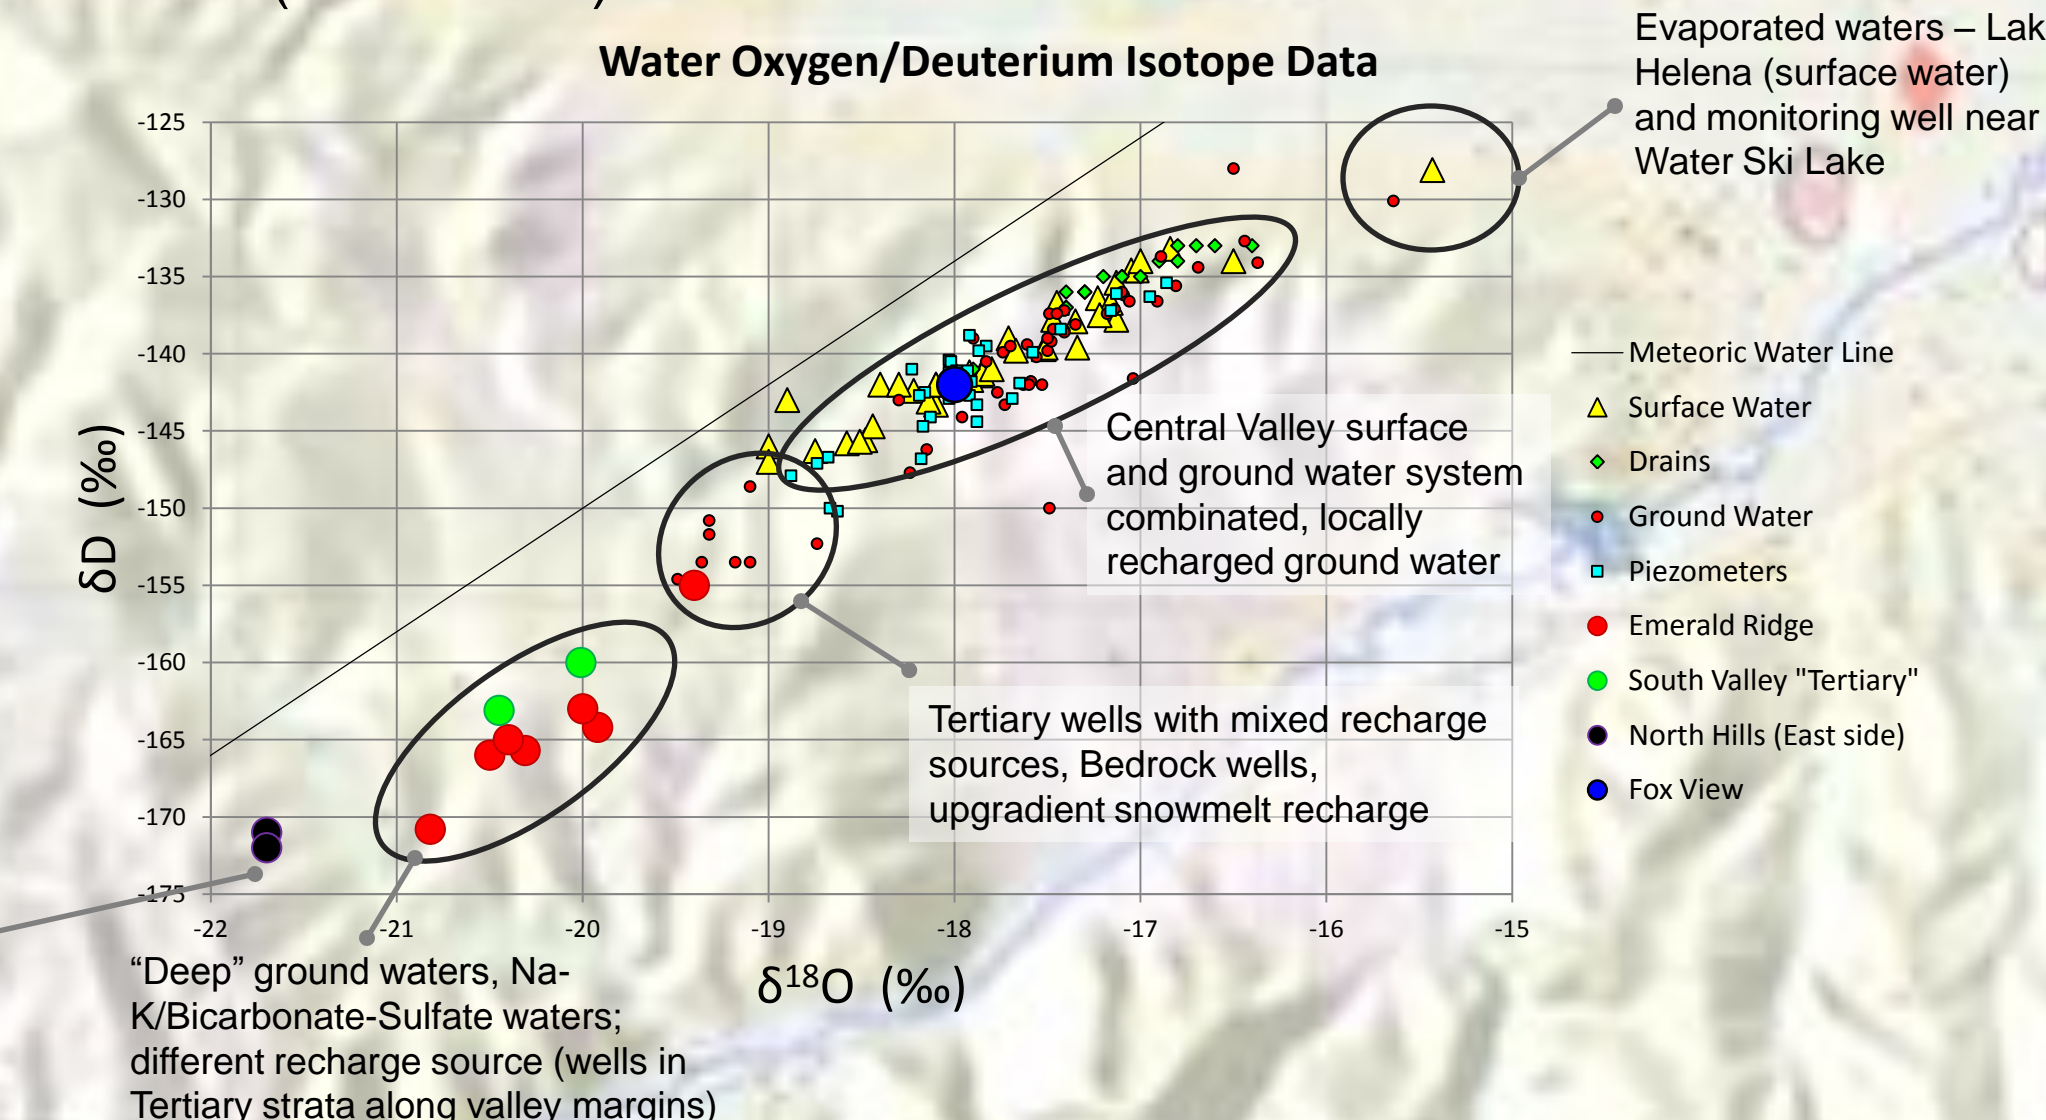
## Isotope Hydrogeology

Conclusion – Distinct Water Type Difference from Area Waters
